## The Influence of Microstructure on the Corrosion Rate of Carbon Steels

### Abstract

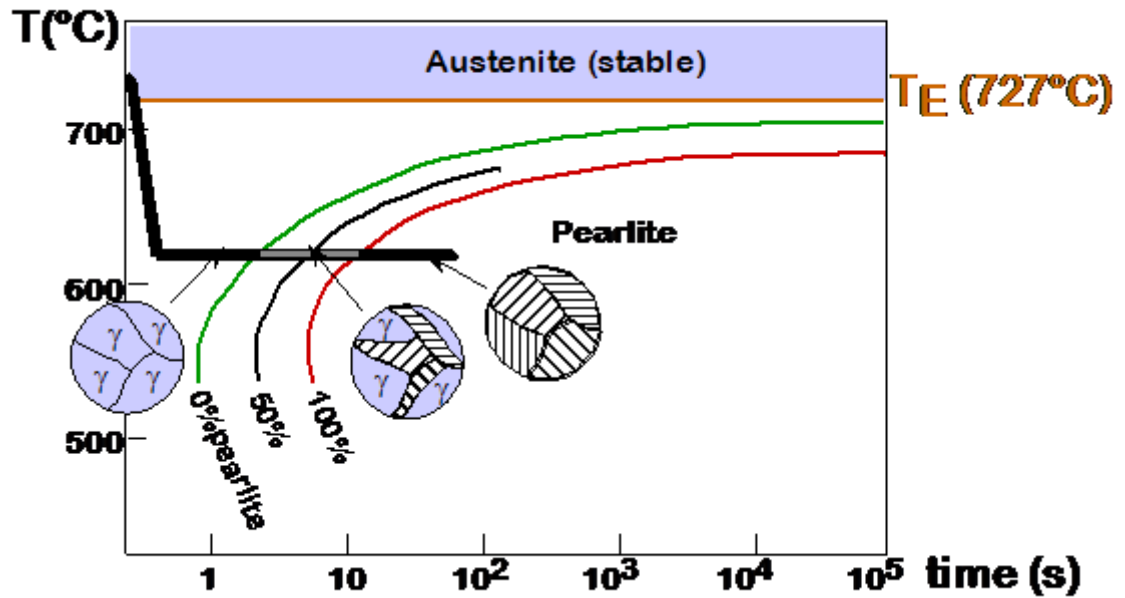
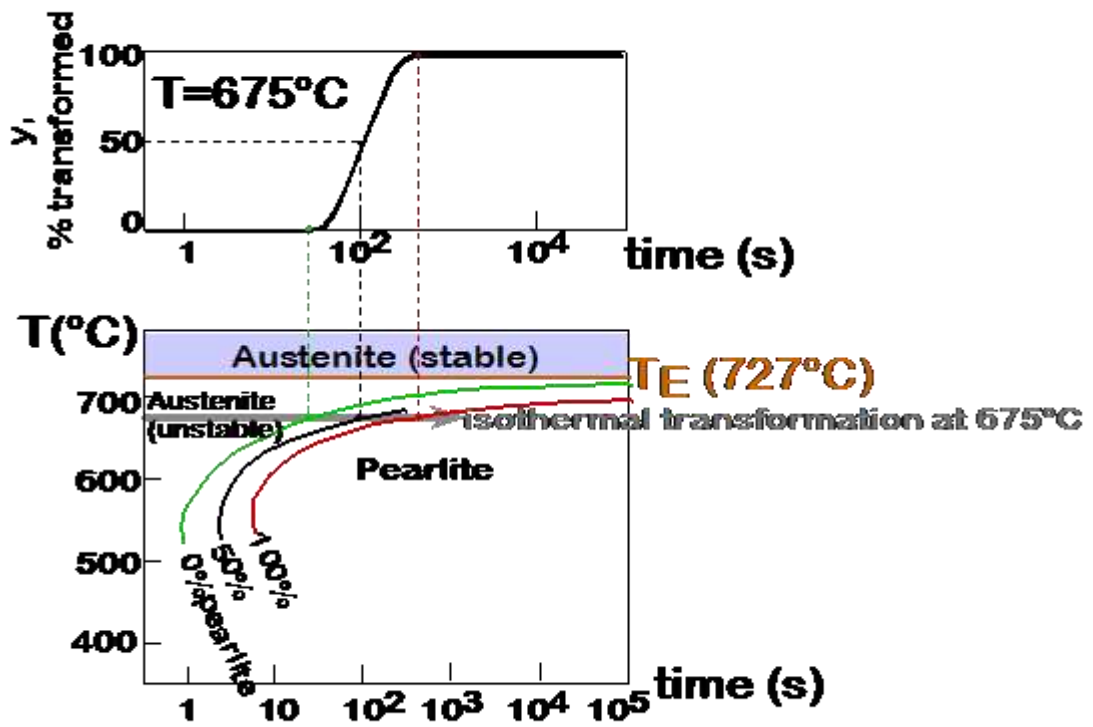
(A) Rapidly cool to 625 °C and hold isothermally

(B) Rapidly cool to 675 °C and hold isothermally

Figure 2: The heat transformation process to fine and coarse ferrite and pearlite.

The annealing process achieved (as shown in fig.2) at temperatures 760°C and holding time 60 min. The specimens after exposure time were rapidly cooled by water to:

A- 625 °C, which is  $T_{\text{transf}}$  way below  $T_E$ , and hold isothermally for small time, then cooling slowly in furnace after turn off the furnace and leave the door closed as indicated in fig.2.

**B-675°C**, which is  $T_{\text{transf}}$  just below  $T_E$ , then hold isothermally for  $0^3$  seconds, followed by a slow cooling process as shown in fig.2. At these conditions, the nucleation rate will be low, and the growth rate will be high, therefore the diffusion is faster than that in case (A). Grain growth is controlled by atomic diffusion. The high diffusion rates allow for larger grain growth and formation of thick layered structure of pearlite (**coarse pearlite**).

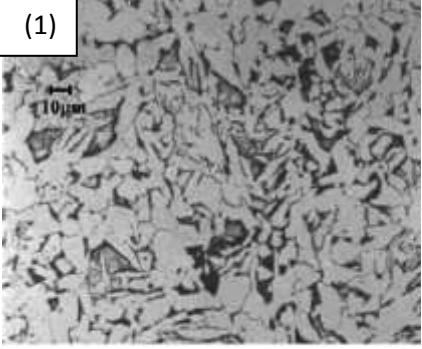
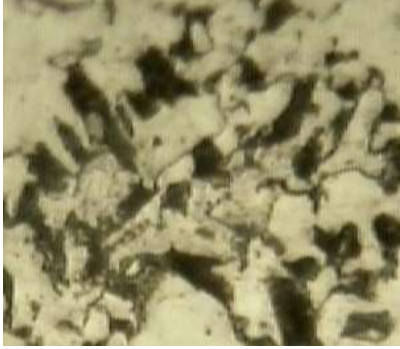
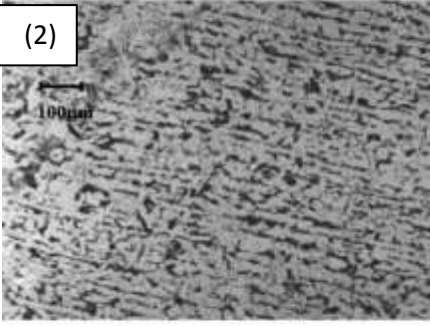
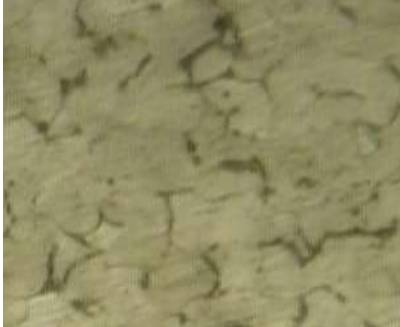
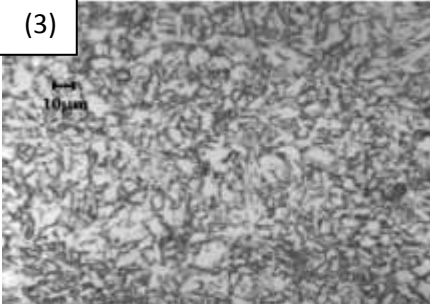
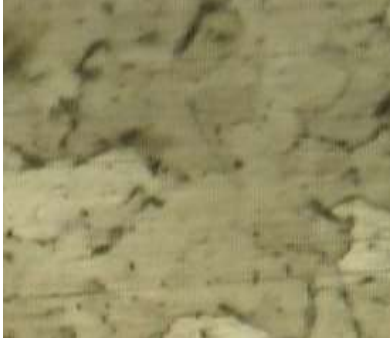
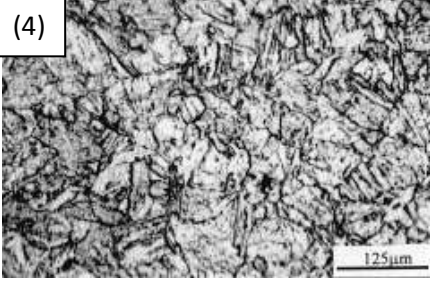
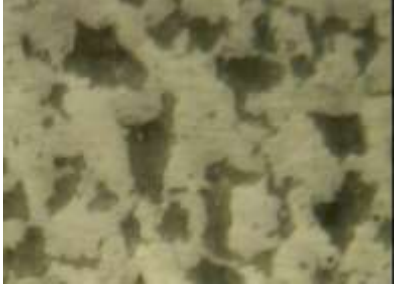
Figure 4: Photographs taken of the various microstructures of carbon steel:

Group 1: banded ferrite/pearlite microstructure.

Group 2: fine ferrite/pearlite microstructure.

Group 3: coarse ferrite/pearlite microstructure.

Group 4: tempered martensite microstructure.

For used carbon steels, the differences in pitting corrosion shapes (as shown in fig. 4) are assigned to the shape and distribution of ferrite and  $\text{Fe}_3\text{C}$  resulting from different heat treatment. The corrosion rate a banded ferrite/pearlite microstructure of used steel presented higher than the F/P microstructure in the annealing and quenching/tempering specimens. A banded ferrite/pearlite structures corrode (as general corrosion) faster than other structures, and steels containing coarse pearlite corrode more rapidly than those with fine pearlite. This results don't agree with the results obtained in work[8], who proposed a mechanism in which the cementite from
