## Investigation Nano-coating for the Corrosion Protection of Petroleum storage tanks Steel

Zainab Z. Ali\*, Bahaa S. Mahdi

This work studies the protection from corrosion in the inner surface of petroleum storage tanks by applying nano-coating on the AISI1018 steel type used in these tanks. BNi-2 alloy, used as coating layer, was deposited using the DC sputtering technique to obtain protection layers of nano-coating. The cyclic potential dynamic polarization technique is used to study and evaluate the resistant metal to localize corrosion, for example, pitting and crevice corrosion. The samples were evaluated in a 3.5% NaCl aqueous solution using the polarization method to determine the corrosion rate. The input parameters of deposition included ion current 16 mA, vacuum  $10^{-1}$  mbar, time of deposition was 60 minutes, and the distance between target and substrate was 2.5 cm. The surface roughness of the uncoated specimens was (0.1466  $\mu\text{m}$ ), and after coating, it decreased to (0.0933 $\mu\text{m}$ ). The most important factor that affects the corrosion of the coated steel surface is the surface topography of steel before coating, as it is known that the spattering

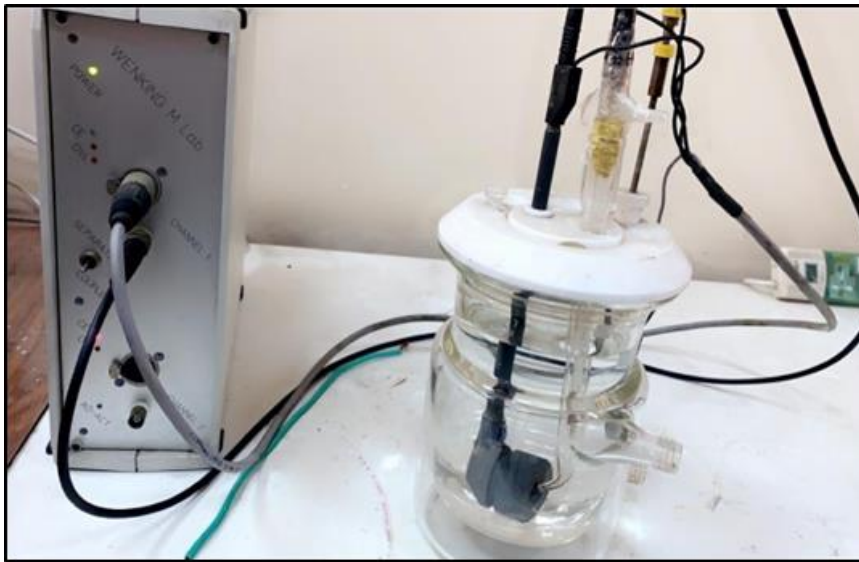
**Figure 2:** Figure 2: The cyclic potential dynamic polarization test device

The corrosion solution comparable to seawater was prepared through a 3.5 wt% NaCl solution by adding 35 grams of NaCl to a liter of distilled water at room temperature. The cyclic potential dynamic polarization was carried out using the potential state as shown in Figure 2.
