Effect of Nickel Coating on Fatigue Resistance of Carburized AISI 301 Stainless Steel

The present research deals with the study of the effect of Nickel Coating on the fatigue resistance of carburized and uncarburized AISI 301 stainless steel. Six groups of bending fatigue specimens were prepared for fatigue test.

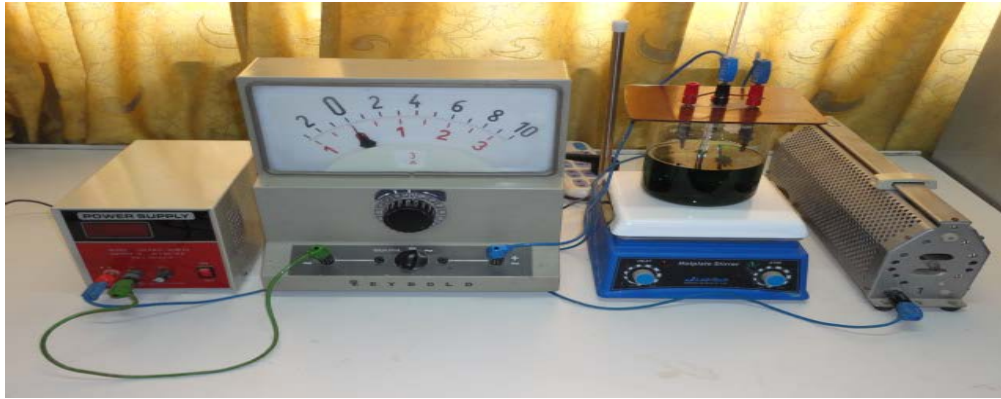
Figure. (1) Nickel electroplating cell.

Nickel coating was performed by Nickel solution (NiSO_4 180g / litter, H_3BO_3 30 g /litter and Ammonium Chloride NH_4CL 25g/litter) at 0.03Amp current , at 50°C for 30 minute by using the Nickel coating electric cell shown in Figure (1) [11].

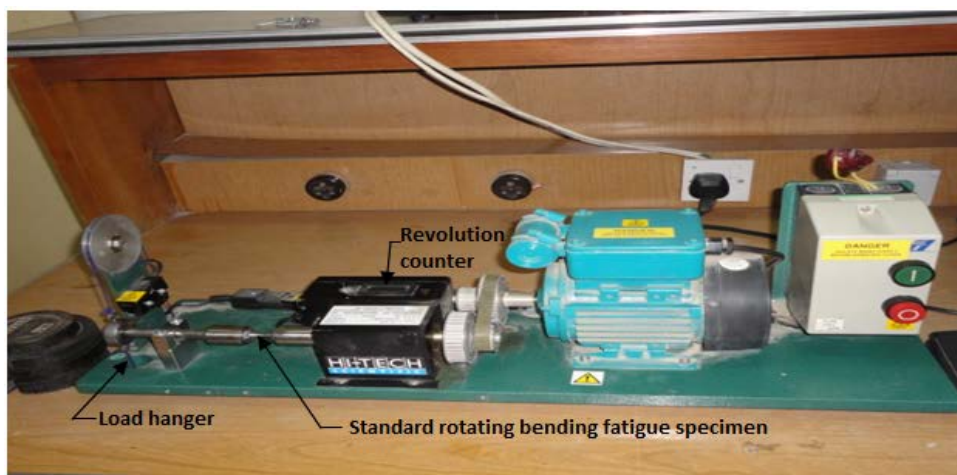
Figure. (2) Rotating bending fatigue apparatus type (HSM19mk3 Hi-Tech Ltd., UK)

All the specimen groups that have been described in Table(2) were subjected to rotating bending fatigue tests up to fracture under different stress levels by rotating bending fatigue apparatus type (HSM19mk3 Hi-Tech Ltd., UK), as shown in Figure (2).

Three tests were conducted for each applied stress and the average values were considered. The Stress versus Number of cycles curves (S-N) were then plotted, and the surface and core hardness were measured by (OTTO WOLPERT-WERKE, GMBH) hardness tester, as listed in Table (3).

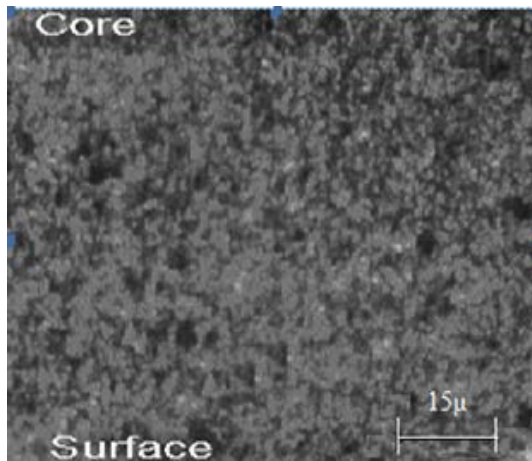
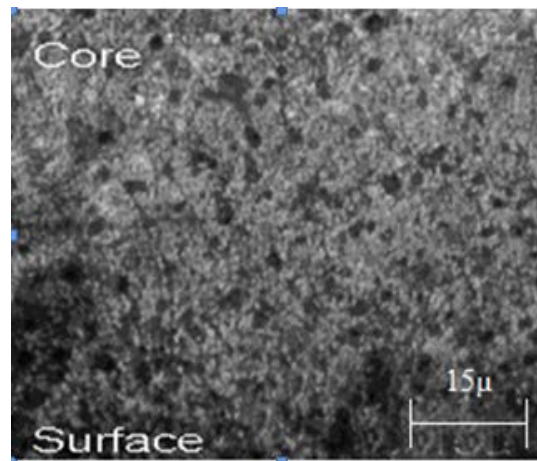
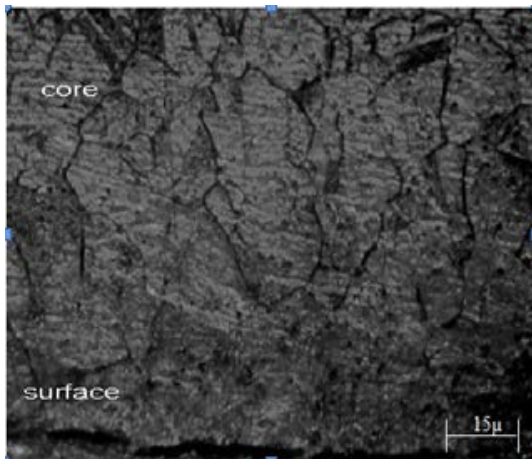
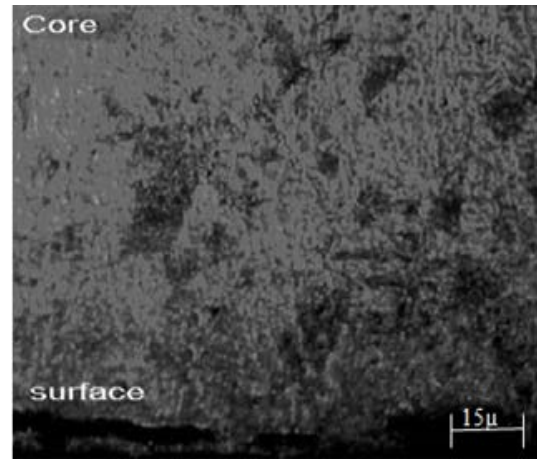
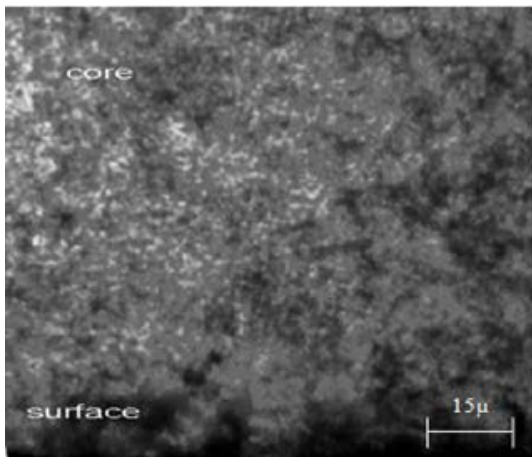
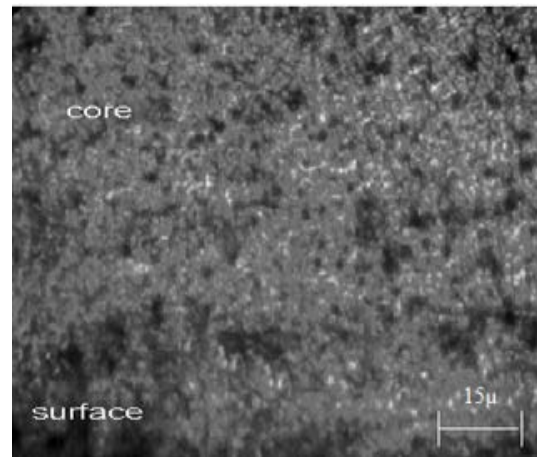
Figure. (3) The microstructure of the six groups of AISI 301stainless steel specimens.

(a) As received (uncoated)

(b) Nickel coated, Layer Thickness: 32µm

(c) Carburized at 950°C for two hours.
Layer thickness: 211µm

(d) Nickel coated then carburized at 950°C
for two hours. Layer thickness: 300µm

(e) Carburized at 540°C for 90 minute.
Layer Thickness: 56 µm

(f) Nickel coated then carburized at 540°C
for 90 minute. Layer Thickness: 78 µm

The microstructure of as received and other treated specimens were photomicrographed by Union Metallurgical Microscope, (Union ME-312S, Japan). Figure (3) shows the microstructure of as received AISI 301 stainless steel alloy and for the specimens of other groups.

Plate "a", from figure (3) reveals the microstructure of as received 301 stainless steel, which consists of carbide (dark) formed in austenitic matrix. Plate "b", shows the structure after being Nickel plated to a layer of 32 microns. In plate c, the pack carburizing layer has a depth of 211 microns, hence sensitization occurred due to formation of Chromium carbides at grain boundaries impairing fatigue resistance. The coating layer increased to 300 micron at plate "d", due to both Nickel and Carbone diffusion toward the core. Plate "e", shows that a layer of only 56 microns formed on specimen surfaces due to low temperature carburization at 540 °C, while plate "f" shows that this layer decreased to 78 microns as compared to plate "d" due to the Nickel plating which impedes the diffusion of carbon during low temperature carburization.

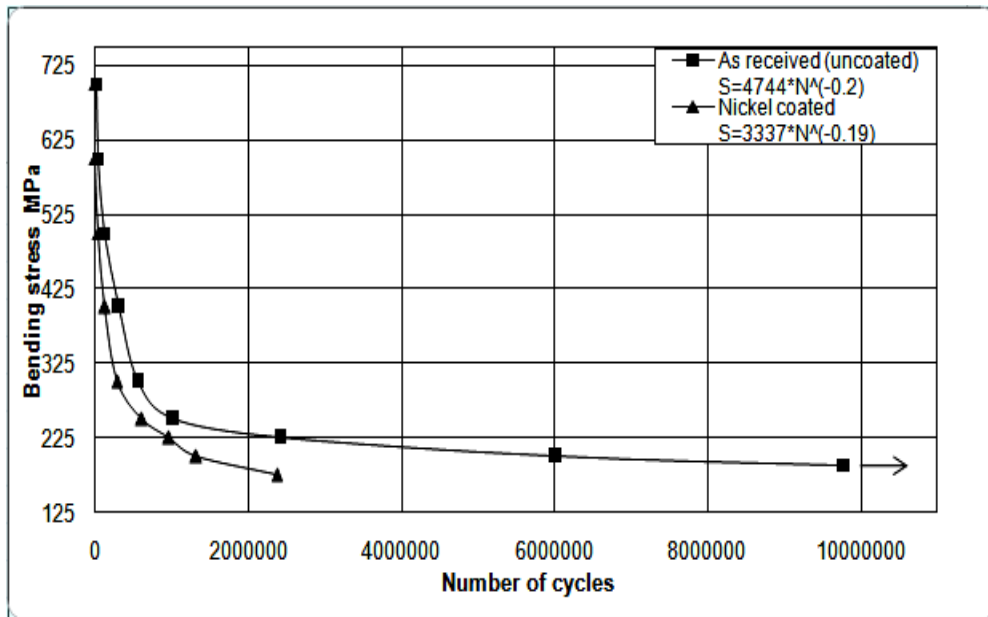
Figure. (4) The effect of Nickel coating on fatigue resistance of AISI 301stainless steel.

Figure (4) represents the S-N curves for both uncoated (as received) and Nickel coated AISI 301stainless steel. The curves show that fatigue resistance of Nickel coated AISI 301 stainless steel decreased by 17.3% as compared with uncoated specimens. The reduction in the fatigue resistance of Nickel coated AISI 301stainless steel can be attributed to the residual tensile stresses that have been developed on the surface layers due to Nickel plating which decreased the fatigue resistance of Nickel coated specimens[12].

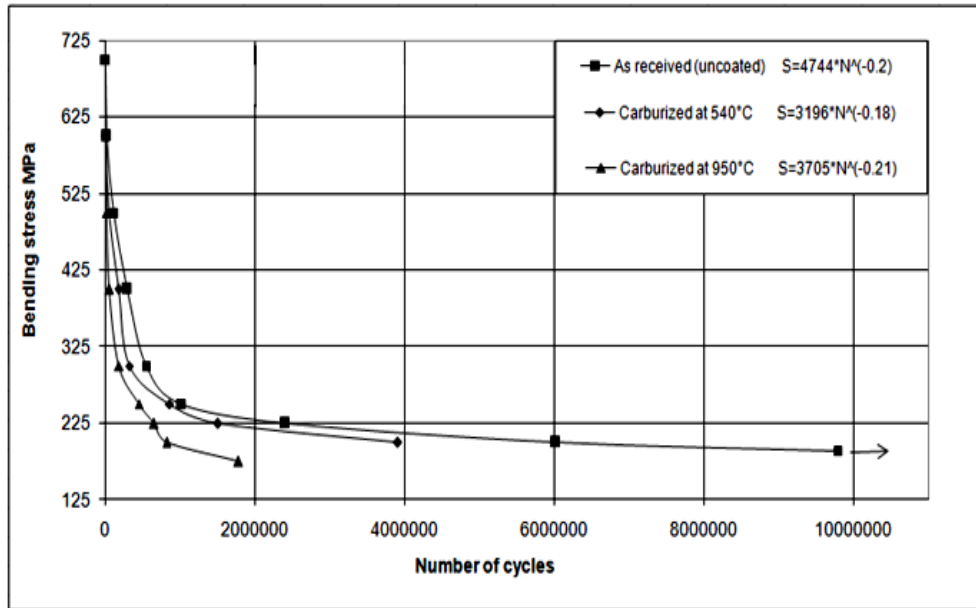
Figure. (5) The effect of carburization at temperatures 950°C and 540°C on fatigue resistance of AISI 301 stainless steel.

The S-N curves, plotted in Figure (5) show a decrease in the fatigue resistance by 6.9% for the specimens carburized at low temperature (540°C), while the fatigue resistance was decreased by 33.5% for specimens carburized at high temperature (950°C) as compared with the uncoated (as received) specimens. The figure also reveals that the fatigue resistance for the specimens that have been carburized at low temperature (540°C) was higher than those specimens that have been carburized at high temperature (950°C). That decrease in the fatigue resistance of high temperature carburization can be attributed to the microstructure changes and grains coarsening that have been resulted due to high temperature in the AISI 301stainless steel as shown in Figure (3c), which led to a degradation in the fatigue resistance. Hardening by high temperature carburization was not suitable to chromium-containing alloys such as stainless steel, due to chromium carbide formation, which is in agreement with Natishan [8].

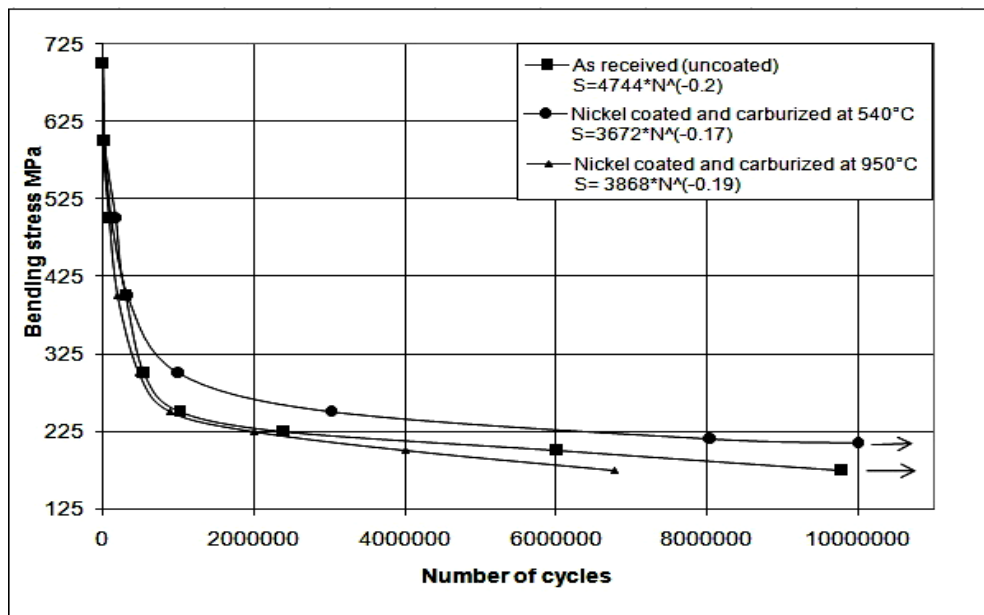
Figure. (6) The effect of Nickel coating and carburization at temperatures 950°C and 540°C on fatigue resistance of AISI 301 stainless steel.

The fatigue resistance of AISI 301 stainless steel specimens coated by Nickel, then carburized at both low (540°C) and high (950°C) temperature, are shown in Figure (6). The results clearly show a 25% improvement in the fatigue resistance for those specimens that have been Nickel coated then carburized at low carburizing temperature (540°C), while the Nickel coated specimens that have been carburized at (950°C) show 4.19% decrease in fatigue resistance, as compared with the as received specimens.

The increase in the fatigue resistance of the specimens coated by Nickel then carburized at low temperature (540°C) was due to Nickel coating layer that have been deposited on the specimen surfaces which reduced the diffusion of carbon across the surface towards the core of AISI 301stainless steel specimens. As a result chromium carbide formation was decreased , as well as the carburization layer has favorable compressive residual stresses that help the part to withstand cyclic loading to which it was exposed [1].

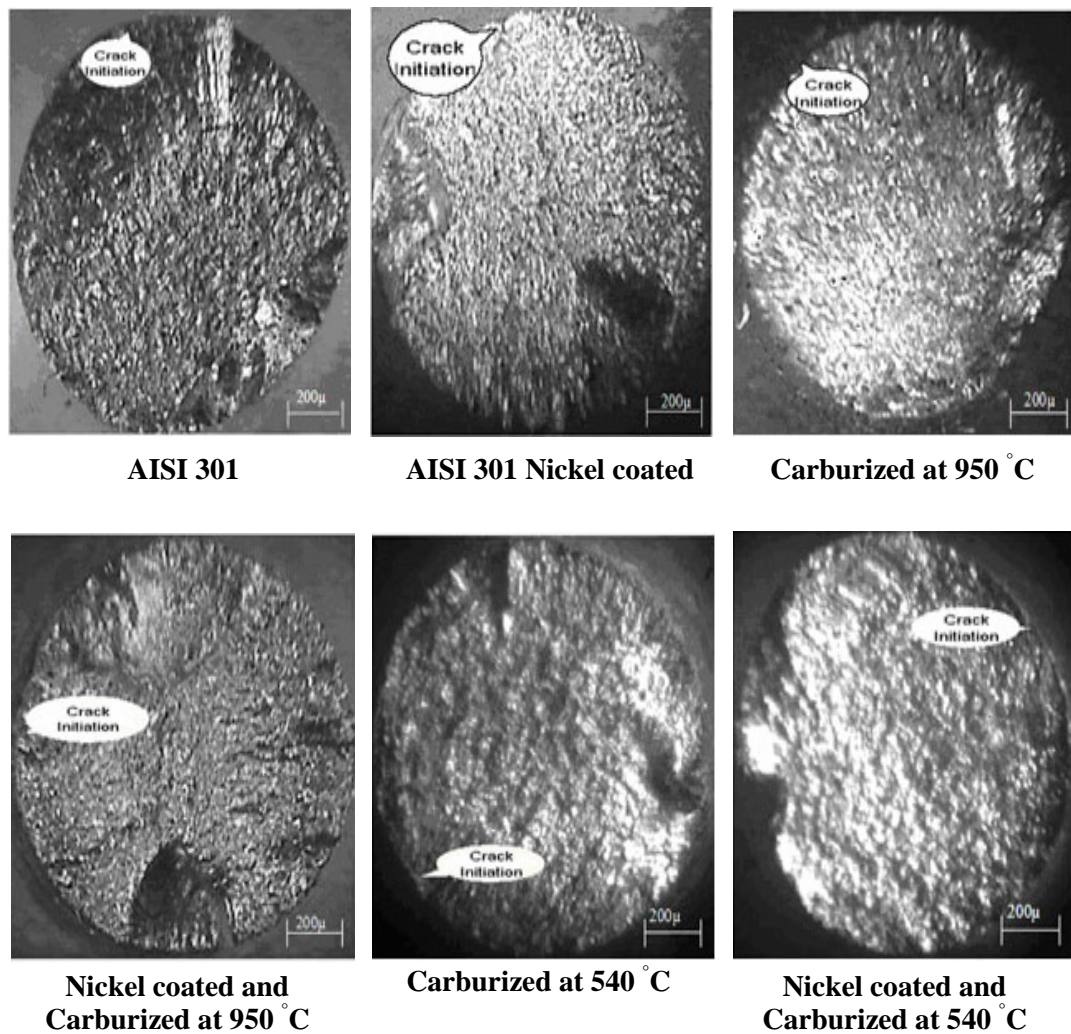
Figure. (7) Fractured regions micrographs of the six groups tested under 20N load.

The fractured regions were photographed by Stereo- Microscope, as shown in Figure (7). Examination of the fractured surfaces shown in Figure (7), show that fatigue cracks were initiated at a Racket mark, where progressive flat fatigue fractured with cross beach marks, until fast over load fracture had taken place ending with shear lips.
